### **The Church of Meryem Ana in Göreme, Cappadocia, correct documentation for a meaningful heritage at risk**

## The Church of Meryem Ana in Göreme, Cappadocia

### Correct documentation for a meaningful heritage at risk

Maria ANDALORO<sup>1</sup> | Tatiana PIGNATALE<sup>2</sup> | Giorgio VERDIANI<sup>2</sup>

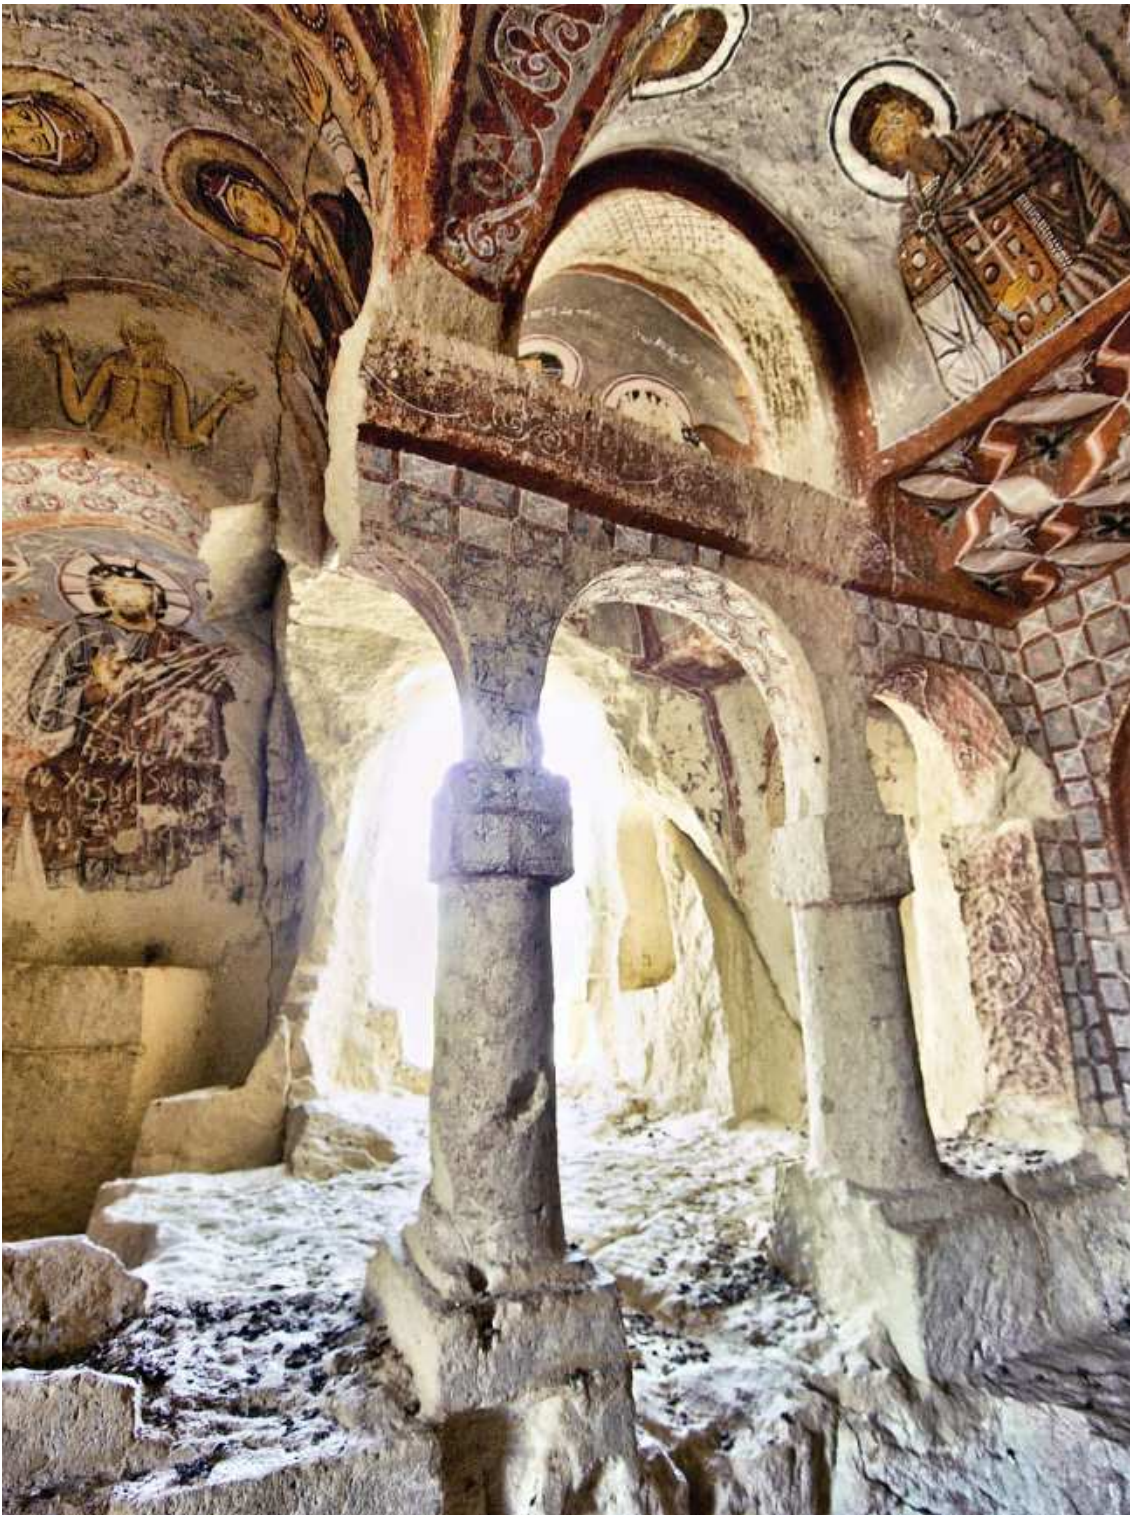
Fig. 1 – View of the inside of the church
